Cape Cod Canal
Massachusetts

**SAGAMORE
HIGHWAY BRIDGE**

1976 Condition Report

CONTRACT NO. DACW 33-76-C-0005

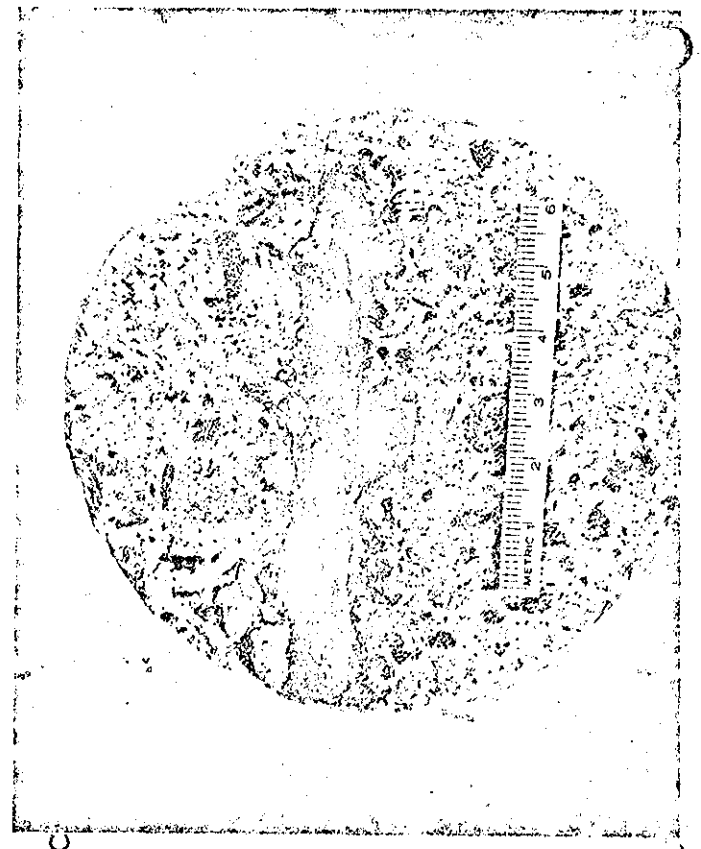
Fig.1 A--Core S-6 with honeycombed Haydite-aggregate concrete overlain by traprock-aggregate concrete. Six-centimeter scale. B--Core B-2 with abundant honeycombed Haydite-aggregate concrete. Compressive strength is 1320 psi. C--Core B-1 with intensely corroded rebar and adjacent corrosion products.

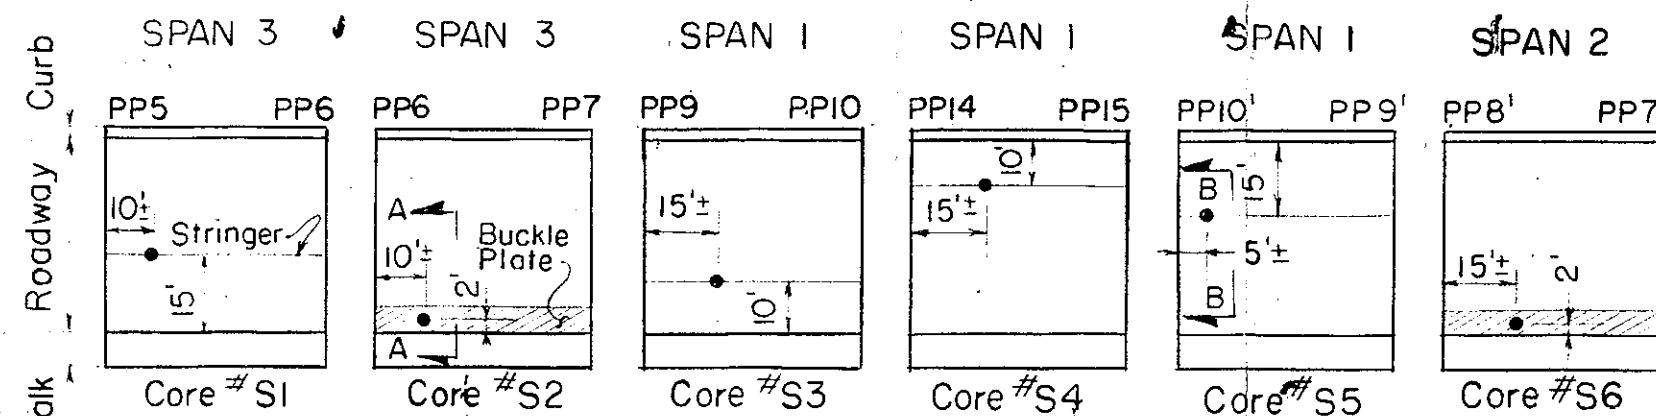
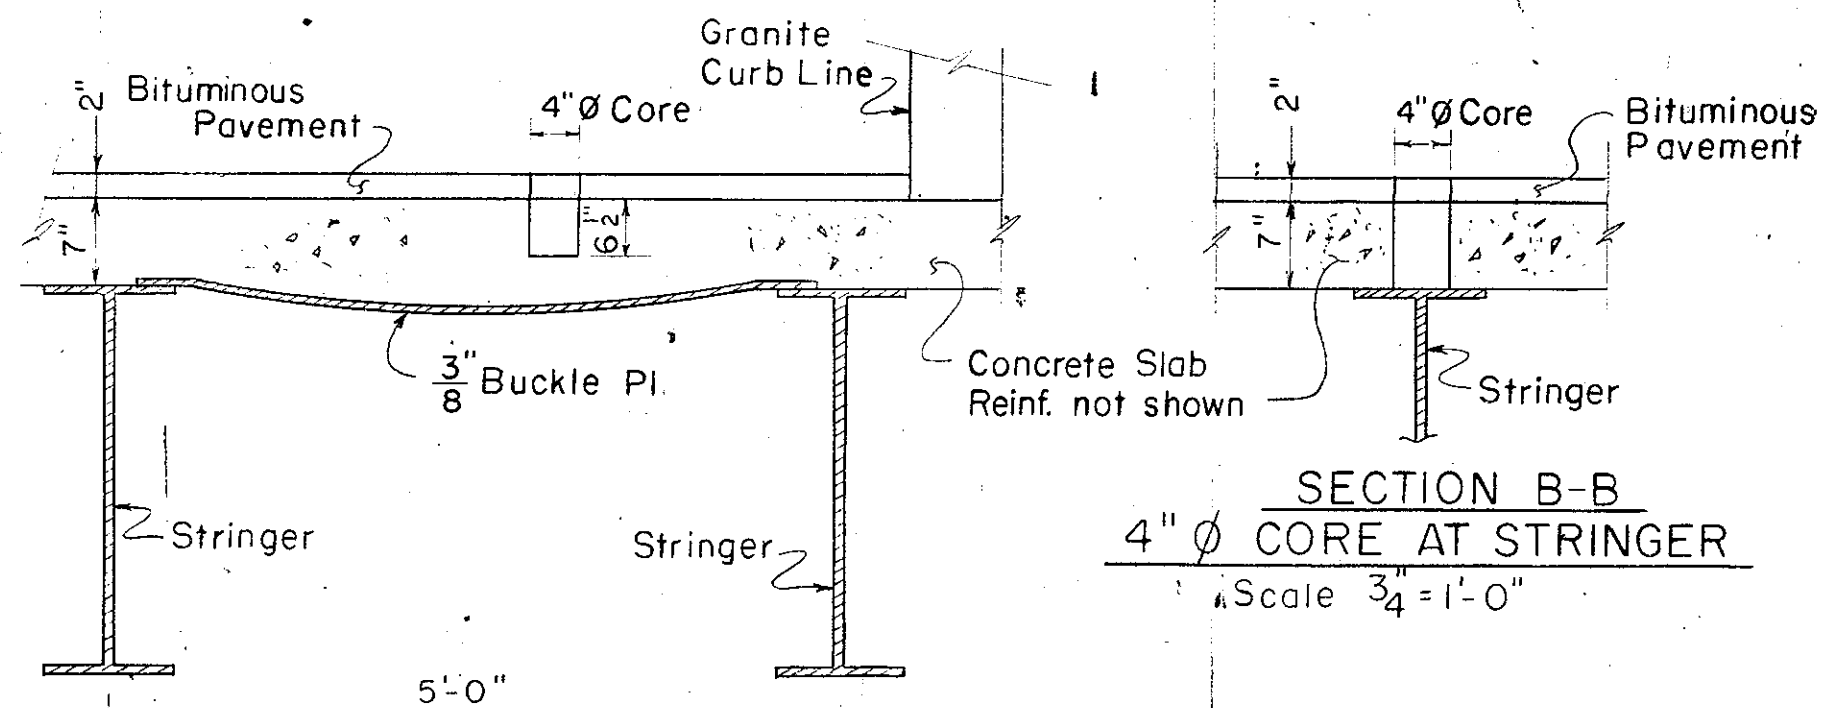
CORE LOCATIONS

To properly evaluate the concrete condition of the deck slab, it was decided to take six 4-inch diameter cores for compressive strength tests, petrographic tests and chloride tests. Figure 9 shows the locations of these six core tests. The tests were performed by the Portland Cement Association. Details of the test results are reported in Appendix II and are summarized in Table B.

Core No.	Condition	Compressive Strength (psi)	Pounds Chloride/Yd ³ Concrete	
			Top	Bottom
S1	Some honey-comb	-	0.07	<0.07
S2	Very good	8,140	<0.07	<0.07
S3	Relatively good	3,040	<0.07	0.64
S4	Much honey-comb	-	<0.07	0.32
S5	Poorly compacted	-	0.08	0.08
S6	Very bad honeycomb	-	0.08	2.51

Additionally, the chloride content in at least one core was excessive. The measured values in Core S6 were 2.51 pounds per cubic yard; whereas the generally acceptable limit of chlorine content is 1 to 1.3 pounds per cubic yard. This excessively high chloride content accelerates the deterioration of both the concrete and the rebars.

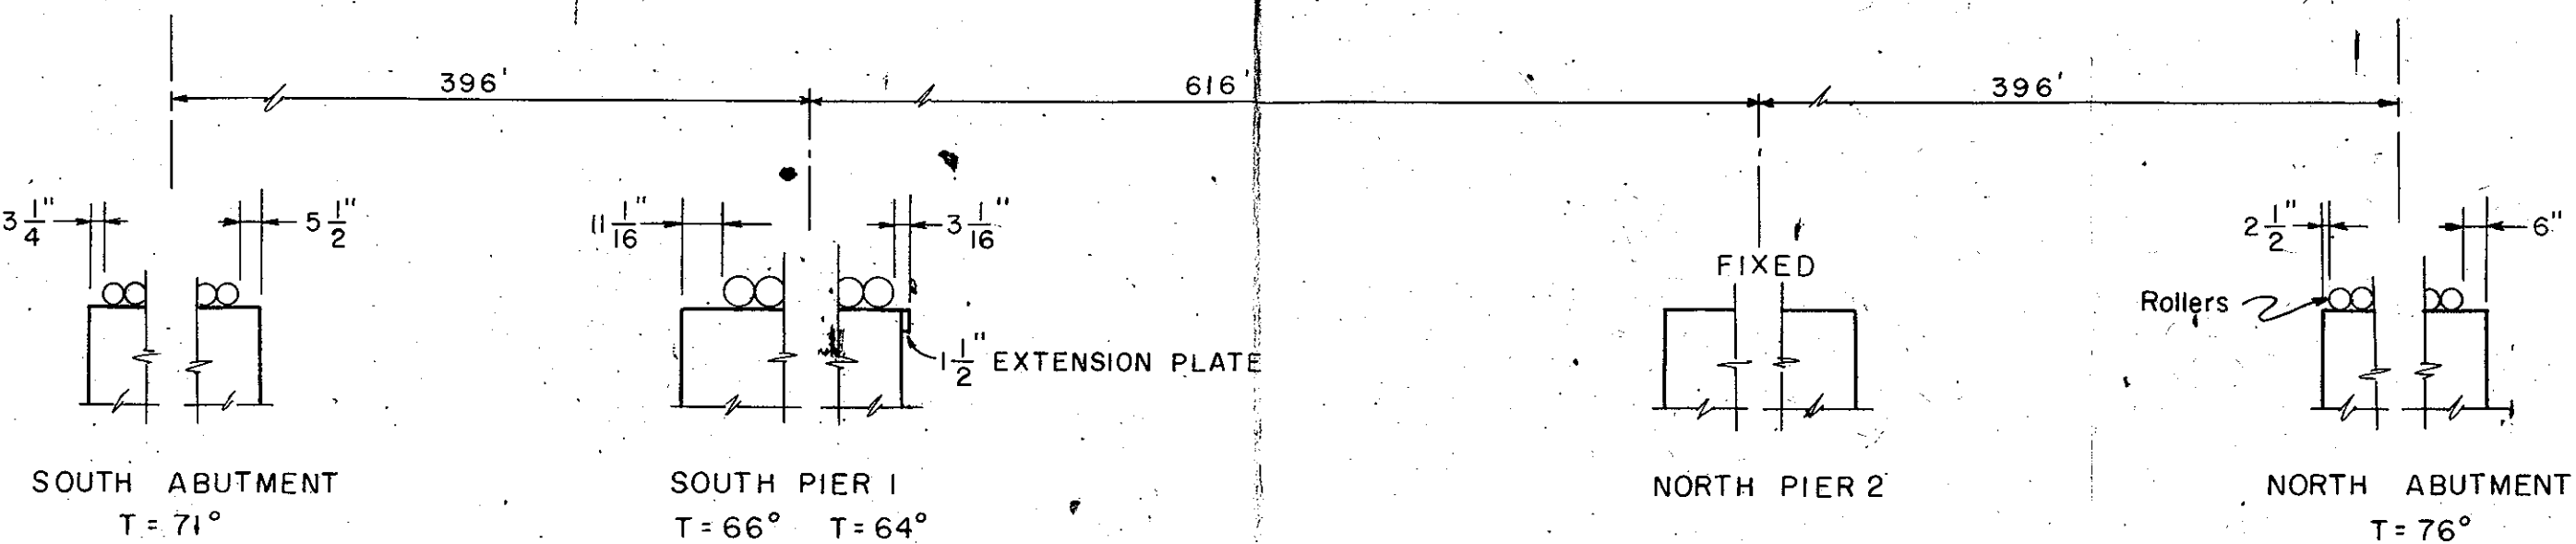
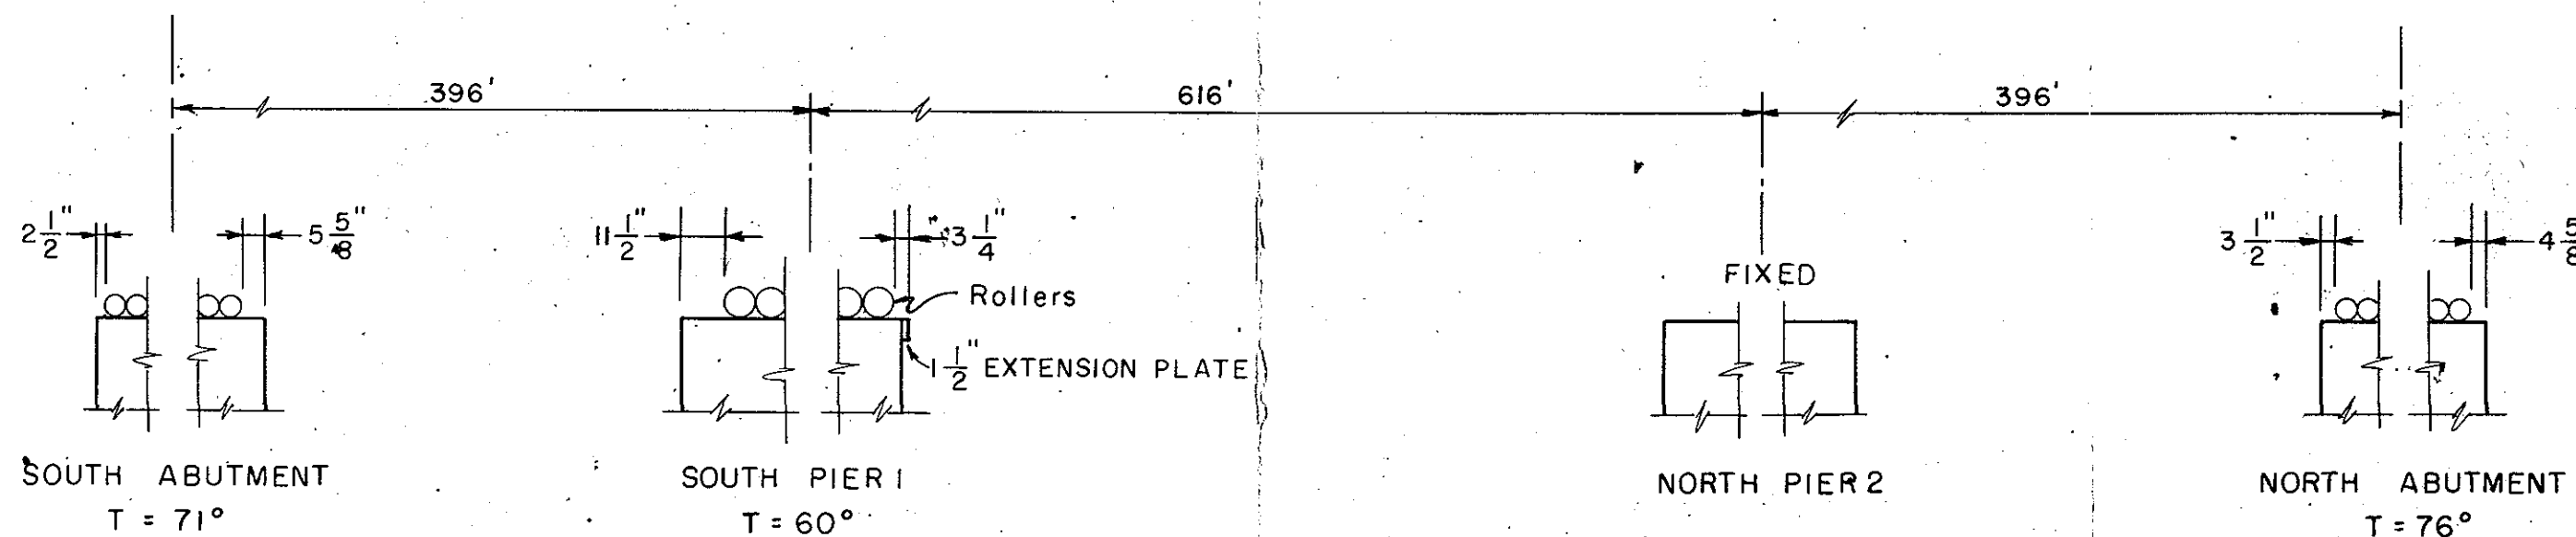
BEARING POSITIONS

All truss bearings were inspected and found to be in good condition and functioning properly, with the exception of anchor bolts at some locations which were bent. These anchor bolts should be repaired (see Section VI). The position of all the bearings at the time of inspection, with recorded ambient temperature, is shown in Figure 10. A study of the movements of the bearings at extreme temperature conditions, as given by the AASHTO specifications, was made and found to be satisfactory.
